Borescope Inspection

For CF6-50 Engines

Based on the Non Destructive Test manual (GEK 9294)

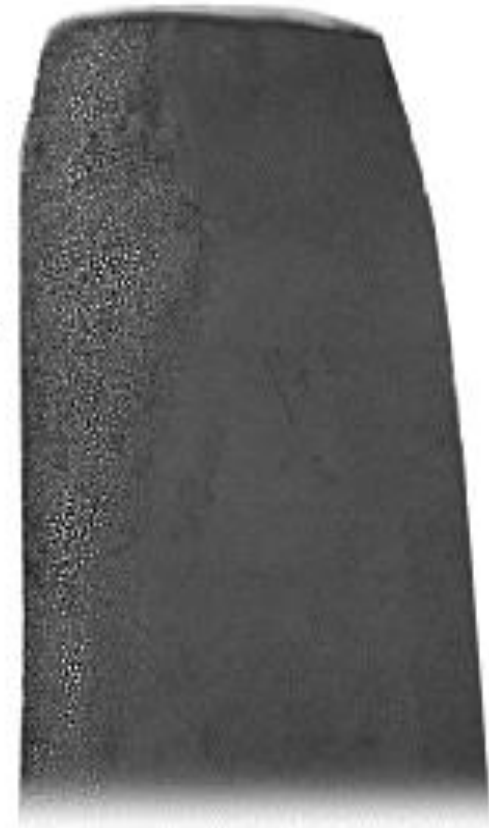
d) EROSION

Erosion is a gradual abrading of the blade surface which is caused by the impact of materials such as salt and sand. This type of damage is usually on the leading edges and concave surfaces of the fan blades and other compressor stages.

NOTE: erosion is a mild and gradual form of foreign object damage

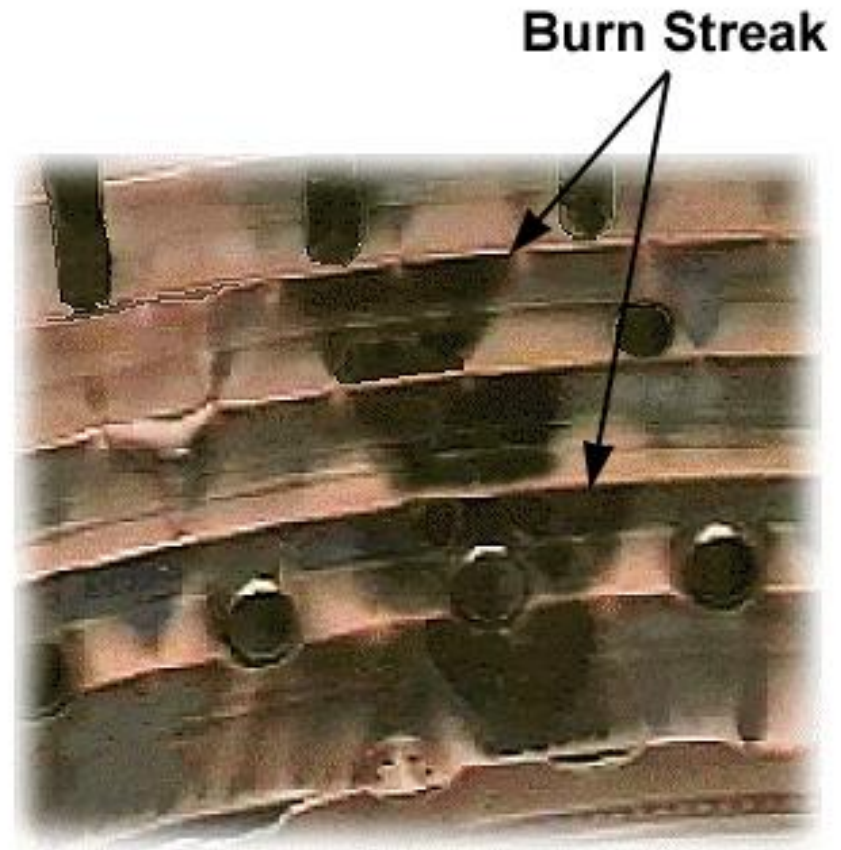
g) BURN STREAK

A burn streak is burning that occurs on several adjacent segments, in an axial direction.

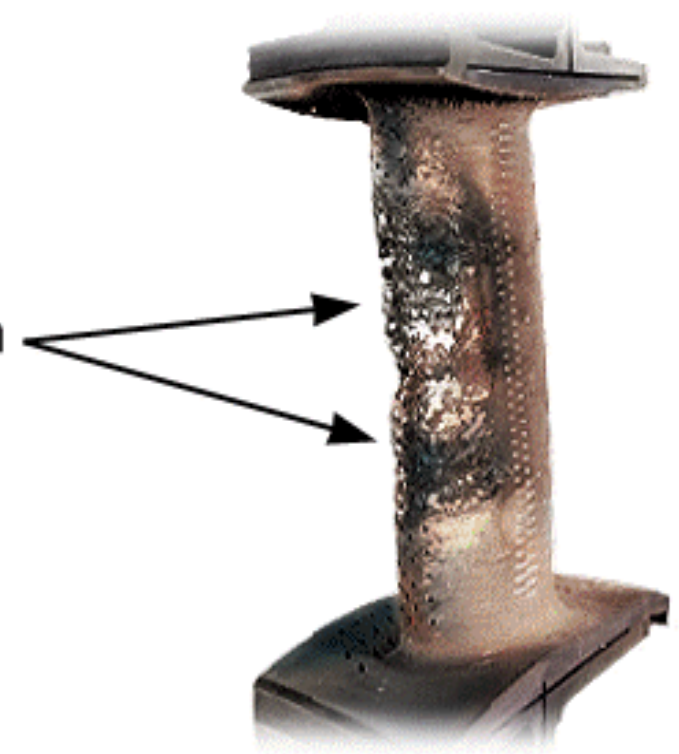
**Structural
Deformation**

q) STRUCTURAL DEFORMATION

Structural deformation occurs if stress (caused by physical forces) and weakened material cause the vanes to bow(bend). This can cause a distortion of the gas flow and reduce engine performance
